IMI Heimeier

M106 actuator for Globo

For Globo ball valves from DN 10 to DN 32

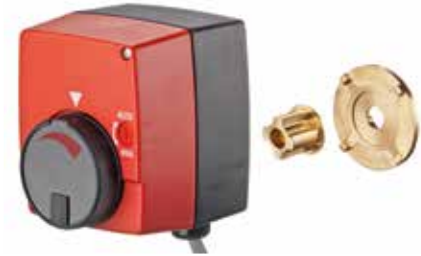
With handwheel

In case of manual emergency actuation
